# Inspection Report

**ASAP  
HOME  
INSPECTIONS**

Inspector:Mike Girard

Property Address

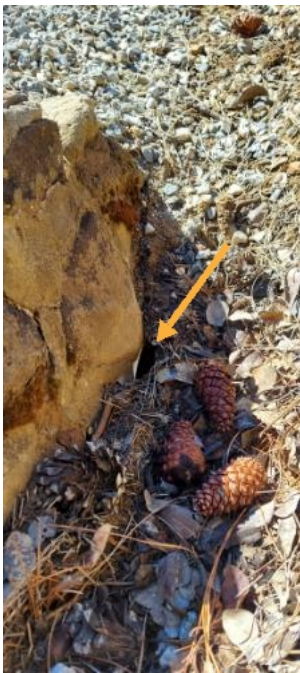
Ri. There is a drain pipe on the side of the driveway that appears plugged. This appears to be part of an occasional maintenance issue.

This drain appears to be plugged.

Recommend this be cleared as part of Maintenance.

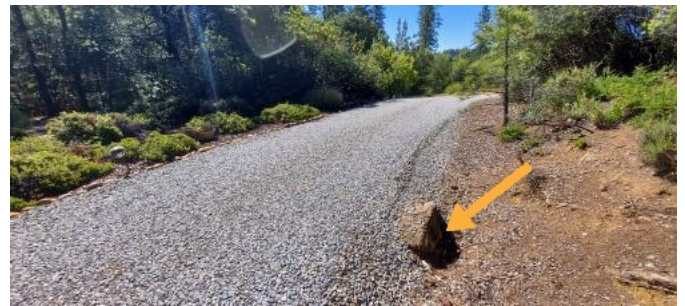
Drain issue location from the previous picture.

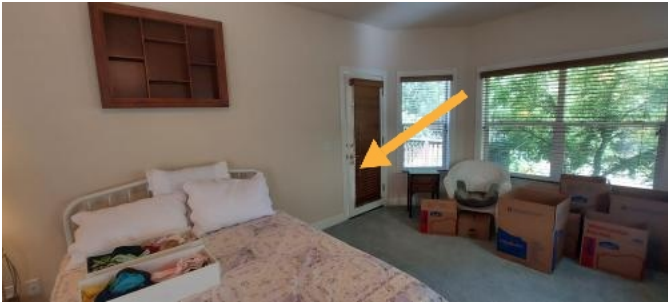
#### R. The rear master exterior door

sticks at the doorframe. Repairs and / or adjustments are recommended by a qualified carpenter.

This door sticks at the door frame here.

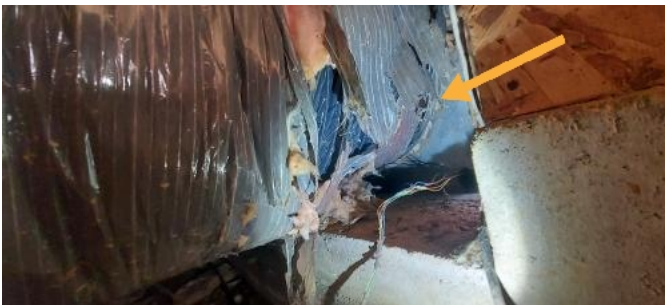
**R. A duct at the plenum**  
appears to be in poor condition. Recommend repairs by a qualified HVAC professional.

This is where some ducting is attached to the plenum. The plenum is the sheet metal ducting that runs from the unit into the crawl space.

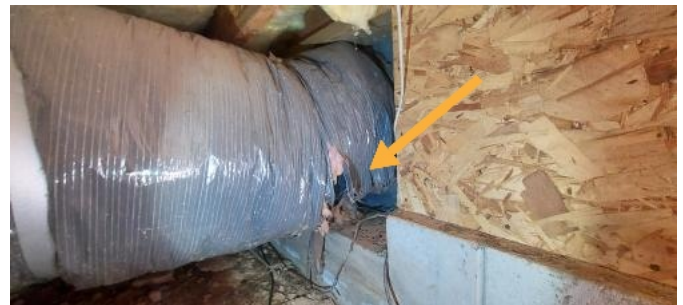
The ducting issue location from the previous picture. This is just on the other side of the unit.

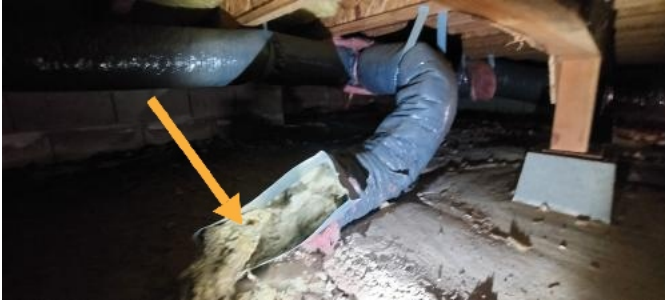
R. It appears a duct has been removed from the living room area. And has been unprofessionally sealed up.

Unused duct. This is not the correct way to seal a duct.

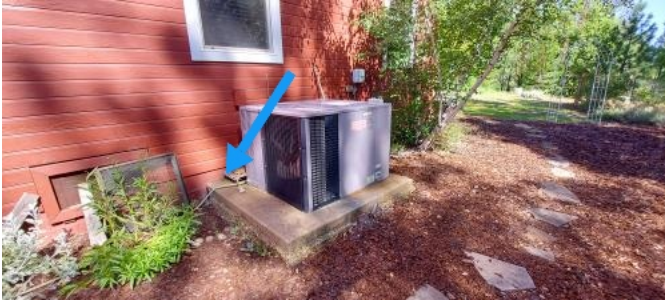
R. The condensate water drain line was missing at the time of the inspection. Recommend installing a drain with a "P" trap. The "P" trap is used to prevent insects from making a nest inside the unit.

A garden hose was used for a drain for the A/C. We recommend the drain be made of PVC pipe with A "P" trap installed

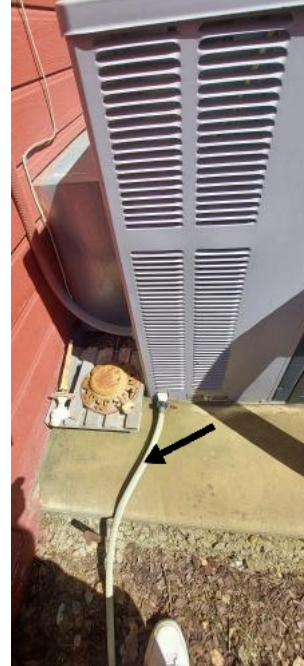
Garden hose ysed as a drain.

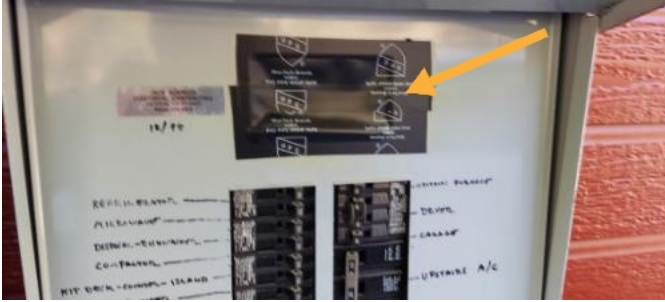
R. The **main panel** was missing covers where breakers were not installed. Recommend installation of standard plastic covers for safety.

Recommend covers be installed

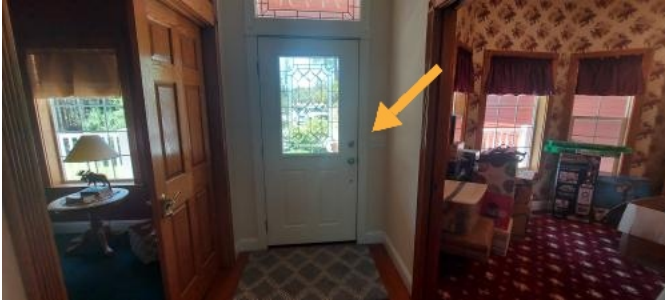
N. There is a spare switch by the **front door** that is for a future exterior light set up.

The middle switch appears to be for an exterior light setup that has not been installed.

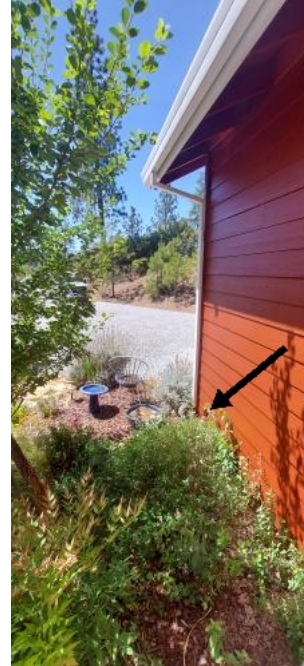
The middle switch appears to be wired up in a Junction Box right here for a future light setup.

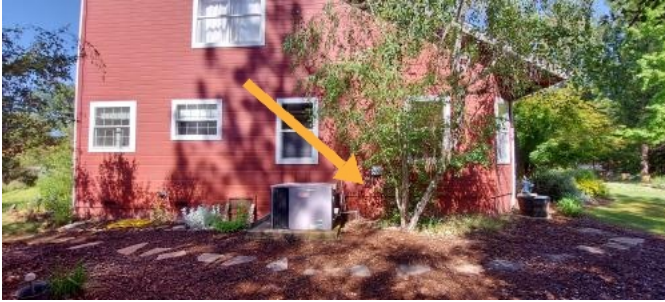
R. The GFCI (ground fault circuit interrupter) receptacle at the **right side** of the home did not respond to the inspectors (external) trip test device. Replacement or repair is needed. Recommend repair by a qualified electrician.

The GFCI Receptacle here is not tripping.

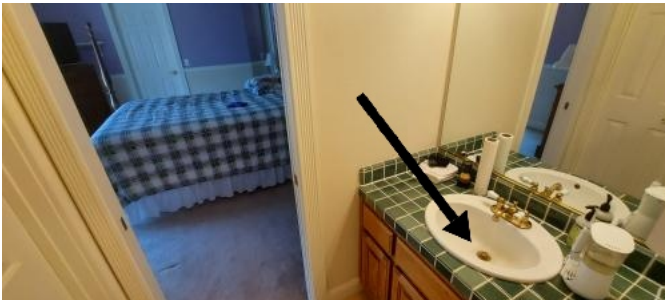
R. The sink drain stopper did not operate in rhe **master bathroom**.

This stopper appears disconnected from the linkage.

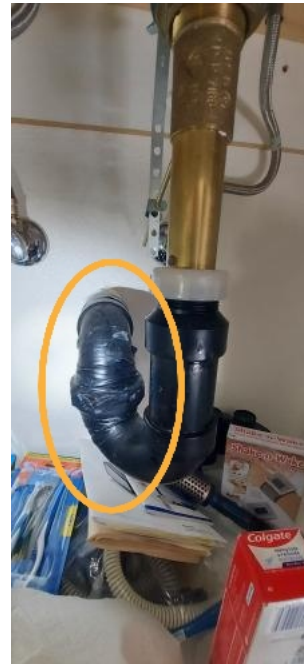
R. There appears to be an unprofesional repair to the plumbing.

Electrical tape is an Unprofessional repair.

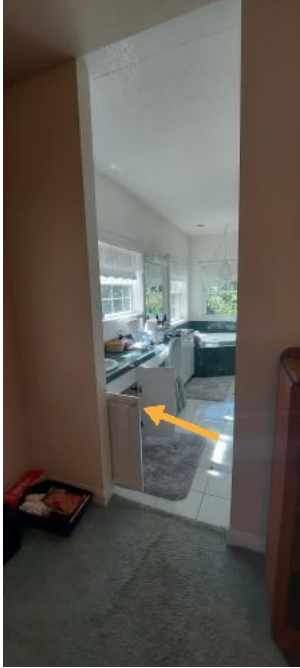
Unprofessional repair issue location from the previous picture.
